**Flood Control Project Maintenance
Levee Inspections**

Fall 2019 Levee Maintenance Deficiency Summary Report

**Flood Control Project Maintenance
Levee Inspections****LMA District Cover Sheet****Fall 2019 Levee Inspection Results****Sacramento Maintenance Yard Willow Slough Bypass**

Sacramento Maintenance Yard Willow Slough Bypass

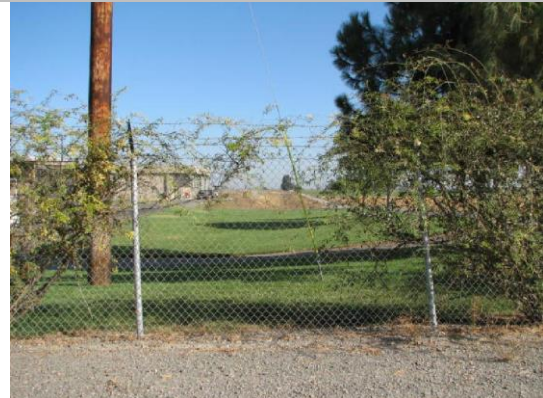
Photo 1 of 3 : UCIP_FA_2019_44903_22882.jpg

Comment Code						
Inspector Comment						
DS_ID:17834 FS_ID:44903 EP_NO: 10130 Repair Type: No Action Needed Crossing Status: Found UCIP Comments: 01/08/2019 Received updated permit information for this crossing from D. Biswas with the CVFPB. The structure description has been updated with the correct abandonment permit information. (O. Magana - DWR UCIP) 05/02/2017 CVFPB Letter sent April 12, 2012 regarding Permit #10130 - Internal Inspections of Pipes Crossing State Plan of Flood Control Levee. Permit No. 10130 previously referenced in UCIP record was removed--permit does not reference 36-inch pipe. (O. Magana - DWR UCIP) 04/12/2017 Mud/debris on WS removed by JK, RF. (C. Lund - DWR Sacramento Yard) 05/05/2015 Removed debris from the outlet. (C. Lund - DWR Sacramento Yard) 09/19/2012 Minor debris blocking flap gate. Debris/log needs to be removed from the outlet. (P. Amatya - DWR UCIP) FIELD_STRUCT_DESC: 36-inch corrugated metal drainage pipe through the levee, 18 feet below the crown. Flap gate is located on the waterside (WS) end. (no permit was found authorizing 36-inch pipe [pipe is referenced in O&M Manual, Station 271+54]; 36-inch was authorized for abandonment under Permit No. 12789-1, 2018 - City of Davis) [Additional Reference(s): USACE Sacramento O&M Manual Unit 120, Willow Slough Channel Relocation and Levee Construction, February 1947, Drawing No. 50-4-2281 Sheet 4 (Station 271+54)] FS Date: 5/5/2015 8:02:11 AM

Landside view- beyond grass area see drainage inlet

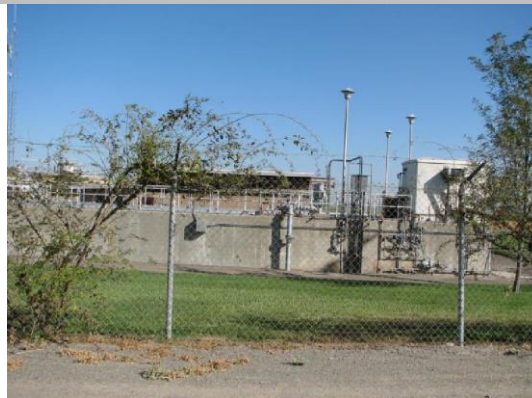
Photo 3 of 3 : UCIP_FA_2019_44904_22886.jpg

Comment Code						
Inspector Comment						
DS_ID:17613 FS_ID:44904 EP_NO: 10309 Repair Type: No Action Needed Crossing Status: Found UCIP Comments: 09/19/2012 Abandoned in place. CMP filled with concrete. (DWR UCIP - P. Amatya) FIELD_STRUCT_DESC: 30-inch steel drainage pipe through the levee, 16.5 feet below the crown. Flap gate is located on the waterside (WS) end. Manhole and grate are located on the landside (LS) toe. (30-inch pipe [HLM 0.01] authorized under Automatic Board Order (ABO) issued as Permit No. 10309, 1974 - City of Davis). [Additional Reference(s): DWR Levee Log, 1990. USACE Sacramento O&M Manual Unit 120, Willow Slough Channel Relocation and Levee Construction, February 1947, Drawing No. 50-4-2281 Sheet 4 (Station 270+70)] FS Date: 5/5/2015 8:02:49 AM

Landside overview- pumping plant not related with this crossing.

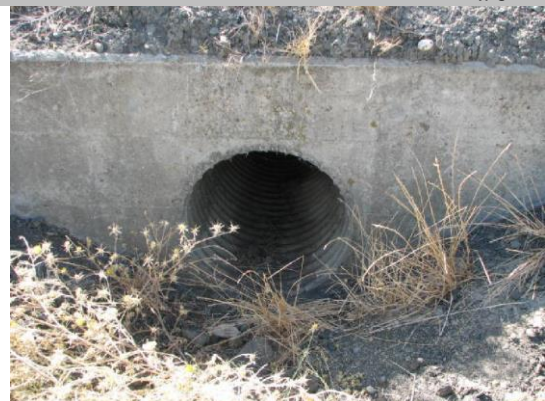
Photo 2 of 3 : UCIP_FA_2019_44907_22893.jpg

Comment Code						
Inspector Comment						
DS_ID:17608						
FS_ID:44907						
EP_NO: 10313						
Repair Type: No Action Needed						
Crossing Status: Found						
UCIP Comments: 04/12/2017 LS - dump has it plugged, WS - ditch need to be established debris higher than water, inspected by JK, RF. (DWR Sacramento Yard - C. Lund)						
09/19/2012 Pipe sits on concrete saddle on WS. (DWR UCIP - P. Amatya)						
FIELD_STRUCT_DESC: 24-inch corrugated metal drainage pipe through the levee, 13.5 feet below the crown. Flap gate is located on the waterside (WS) end. (24-inch pipe [HLM 0.79] authorized under Automatic Board Order (ABO) issued as Permit No. 10313, 1974 - Lear). [Additional Reference(s): DWR Levee Log, 1990. USACE Sacramento O&M Manual Unit 120, Willow Slough Channel Relocation and Levee Construction, February 1947, Drawing No. 50-4-2281 Sheet 2, 4 (Station 232+43)]						
FS Date: 5/5/2015 8:06:14 AM

Landside view- pipe and headwall closer view

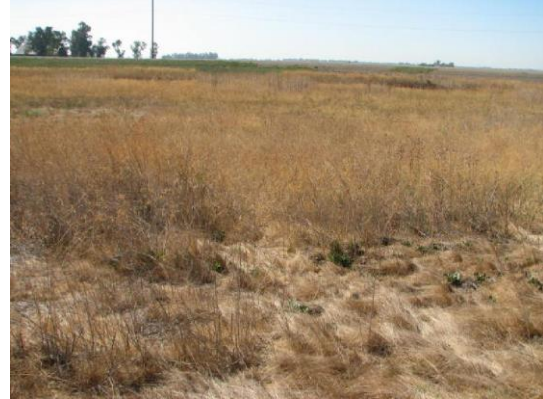
Photo 3 of 3 : UCIP_FA_2019_44907_22892.jpg

Comment Code						
Inspector Comment						
DS_ID:17608 FS_ID:44907 EP_NO: 10313 Repair Type: No Action Needed Crossing Status: Found UCIP Comments: 04/12/2017 LS - dump has it plugged, WS - ditch need to be established debris higher than water, inspected by JK, RF. (DWR Sacramento Yard - C. Lund) 09/19/2012 Pipe sits on concrete saddle on WS. (DWR UCIP - P. Amatya) FIELD_STRUCT_DESC: 24-inch corrugated metal drainage pipe through the levee, 13.5 feet below the crown. Flap gate is located on the waterside (WS) end. (24-inch pipe [HLM 0.79] authorized under Automatic Board Order (ABO) issued as Permit No. 10313, 1974 - Lear). [Additional Reference(s): DWR Levee Log, 1990. USACE Sacramento O&M Manual Unit 120, Willow Slough Channel Relocation and Levee Construction, February 1947, Drawing No. 50-4-2281 Sheet 2, 4 (Station 232+43)] FS Date: 5/5/2015 8:06:14 AM

Waterside view

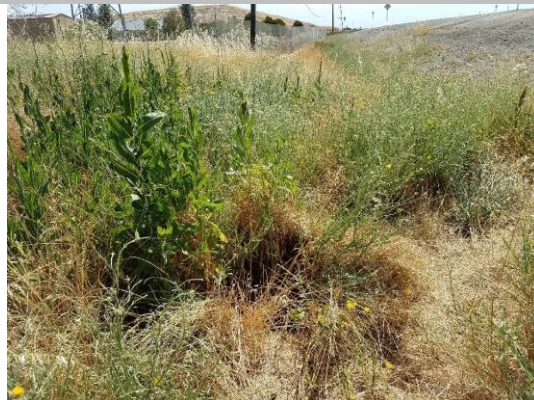
Photo 1 of 3 : UCIP_FA_2019_54247_80003.jpg

Comment Code						
Inspector Comment						
DS_ID:17612 FS_ID:54247 EP_NO: 10315 Repair Type: Non-Urgent Crossing Status: Found UCIP Comments07/01/2019 Crossing has been modified from irrigation siphon to storm drainage prior to 2012. No permit has been found authorizing the modifications to this pipe. Pipe inlet on LS is buried in soil. Sinkhole approximately 2-foot in diameter and 2-foot deep located at LS toe along pipe alignment. This crossing was internally inspected as part of the DWR's Deferred Maintenance Project in 2017. Unable to determine what happened to the pipe section through the channel and opposite levee. Coordinating with LMA and Yolo County to determine owner of crossing. (O.Yakimov - DWR UCIP) 09/19/2012 Looks 24-inch HDPE pipe sleeved through 42-inch pipe. A 30-inch flap gate on WS looks recently replaced. (DWR UCIP - P. Amatya) FIELD_STRUCT_DESC: 24-inch drainage pipe sleeved through an existing 42-inch siphon steel irrigation pipe through the levee, 13.5 feet below the crown. 42-inch pipe cut off and steel plate welded at WS toe, annular space seems to be filled with cement slurry. Pipe inlet enclosed into concrete casing on the landside (LS) end. (42-inch pipe authorized under Automatic Board Order (ABO) issued as Permit No. 10315, 1974 - Reclamation District No. 2035) [Additional Reference(s): DWR Levee Log, 1990. USACE Sacramento O&M Manual Unit 120, Willow Slough Channel Relocation and Levee Construction, February 1947, Drawing No. 50-4-2281 Sheet 2 (Station 193+70)] FS Date: 7/1/2019 3:27:02 PM

Landside view

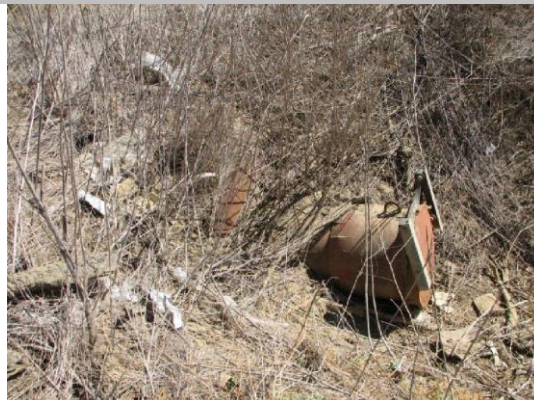
Photo 1 of 3 : UCIP_FA_2019_44929_22929.jpg

Comment Code						
Inspector Comment						
DS_ID:17623						
FS_ID:44929						
EP_NO: 10310						
Repair Type: No Action Needed						
Crossing Status: Found						
UCIP Comments:						
FIELD_STRUCT_DESC: 20-inch steel drainage pipe sleeved though 30-inch corrugated metal pipe through the levee, 12.5 feet below the crown. 24-inch flap gate is located on the waterside (WS) end. (30-inch pipe [HLM 1.53] authorized under Automatic Board Order (ABO) issued as Permit No. 10310, 1974 - Hunt-Wesson Foods, Inc.) [Additional Reference(s): DWR Levee Log, 1990. USACE Sacramento O&M Manual Unit 120, Willow Slough Channel Relocation and Levee Construction, February 1947, Drawing No. 50-4-2281 Sheet 2 (Station 192+88)]						
FS Date: 5/5/2015 8:20:02 AM

Waterside view- pipe and flap gate

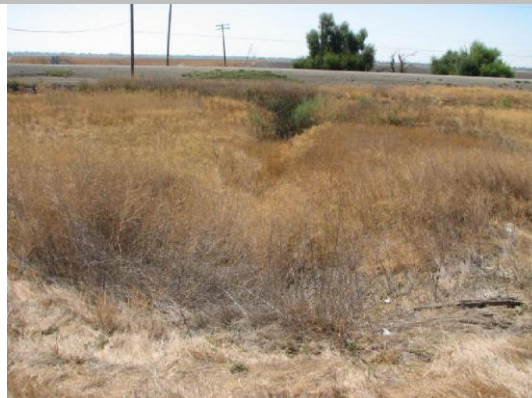
Photo 3 of 3 : UCIP_FA_2019_44929_22931.jpg

Comment Code						
Inspector Comment						
DS_ID:17623 FS_ID:44929 EP_NO: 10310 Repair Type: No Action Needed Crossing Status: Found UCIP Comments: FIELD_STRUCT_DESC: 20-inch steel drainage pipe sleeved though 30-inch corrugated metal pipe through the levee, 12.5 feet below the crown. 24-inch flap gate is located on the waterside (WS) end. (30-inch pipe [HLM 1.53] authorized under Automatic Board Order (ABO) issued as Permit No. 10310, 1974 - Hunt-Wesson Foods, Inc.) [Additional Reference(s): DWR Levee Log, 1990. USACE Sacramento O&M Manual Unit 120, Willow Slough Channel Relocation and Levee Construction, February 1947, Drawing No. 50-4-2281 Sheet 2 (Station 192+88)] FS Date: 5/5/2015 8:20:02 AM

Waterside overview

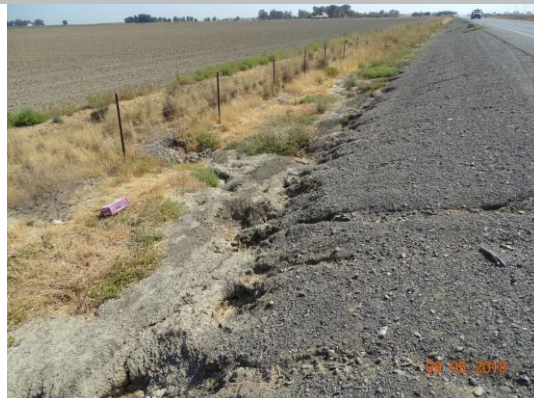
Photo 1 of 3 : FA_2019_ST0012_295_10_20190829_00002.jpg

LM Start	2.93	Rating **	M	Issue No.	10 (cont)
LM End	3.00	Issue Type +	Ma	Location *	LS

View of the erosion on the landside slope. Fall 2018.

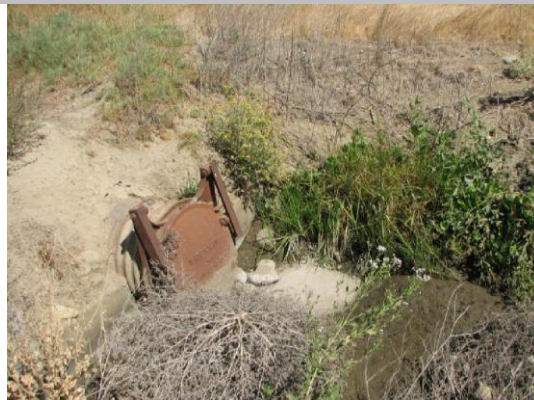
Photo 1 of 3 : UCIP_FA_2019_55421_22967.jpg

DS_ID:17621
FS_ID:55421
EP_NO: 10312
Repair Type: Non-Urgent
Crossing Status: Found
UCIP Comments: 11/01/2019 Received information from Vincent Rodriguez - FMO that this pipe was removed and replaced. Removed Urgent status and will follow up with inspection photo. (O.Yakimov - DWR UCIP)04/09/2019 Internal inspection has been completed and inspection shows major erosion on the WS outlet. Recommend complete removal and replacement. Pipe is in a section of major county road (Road 29). (J. McCabe - DWR Sacramento Yard) 04/12/2017 good/clear on LS & WS, inspected by JK, RF. (DWR Sacramento Yard - C. Lund)
09/19/2012 Depressions on waterside slope of the levee. (DWR UCIP - P. Amatya)
FIELD_STRUCT_DESC: 24-inch corrugated metal drainage pipe through the levee, 10 feet below the crown. Flap gate is located on the waterside (WS) end. (24-inch pipe [HLM 3.08] authorized under Automatic Board Order (ABO) issued as Permit No. 10312, 1974 - Kelly). [Additional Reference(s): DWR Levee Log, 1990. USACE Sacramento O&M Manual Unit 120, Willow Slough Channel Relocation and Levee Construction, February 1947, Drawing No. 50-4-2281 Sheet 1 (Station 110+97)]

Waterside view- pipe and flap gate.

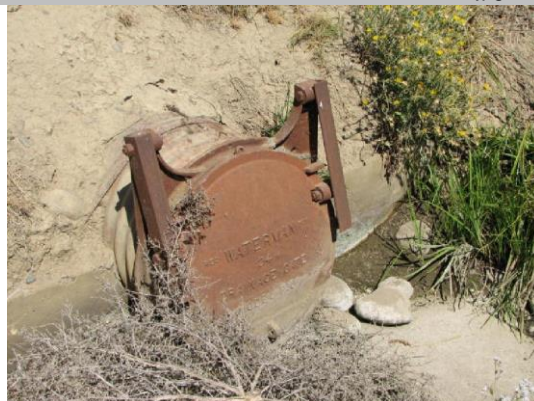
Photo 2 of 3 : UCIP_FA_2019_55421_22970.jpg

Waterside view- pipe and flap gate (close view).

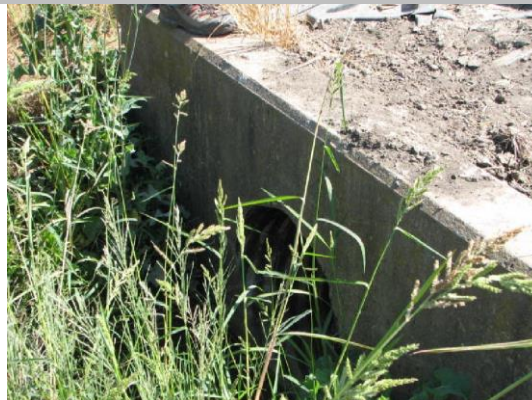
Photo 3 of 3 : UCIP_FA_2019_55421_22969.jpg

Comment Code					
Inspector Comment					
DS_ID:17621 FS_ID:55421 EP_NO: 10312 Repair Type: Non-Urgent Crossing Status: Found UCIP Comments: 11/01/2019 Received information from Vincent Rodriguez - FMO that this pipe was removed and replaced. Removed Urgent status and will follow up with inspection photo. (O.Yakimov - DWR UCIP)04/09/2019 Internal inspection has been completed and inspection shows major erosion on the WS outlet. Recommend complete removal and replacement. Pipe is in a section of major county road (Road 29). (J. McCabe - DWR Sacramento Yard) 04/12/2017 good/clear on LS & WS, inspected by JK, RF. (DWR Sacramento Yard - C. Lund) 09/19/2012 Depressions on waterside slope of the levee. (DWR UCIP - P. Amatya) FIELD_STRUCT_DESC: 24-inch corrugated metal drainage pipe through the levee, 10 feet below the crown. Flap gate is located on the waterside (WS) end. (24-inch pipe [HLM 3.08] authorized under Automatic Board Order (ABO) issued as Permit No. 10312, 1974 - Kelly). [Additional Reference(s): DWR Levee Log, 1990. USACE Sacramento O&M Manual Unit 120, Willow Slough Channel Relocation and Levee Construction, February 1947, Drawing No. 50-4-2281 Sheet 1 (Station 110+97)] FS Date: 11/1/2019 8:12:10 AM

Landside view- pipe and concrete headwall.

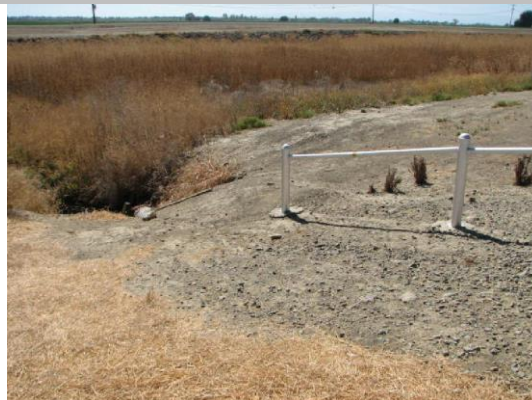
Photo 1 of 3 : UCIP_FA_2019_44947_22984.jpg

Comment Code						
Inspector Comment						
DS_ID:17622						
FS_ID:44947						
EP_NO: 10316						
Repair Type: No Action Needed						
Crossing Status: Found						
UCIP Comments: 04/12/2017 good/clear on LS & WS, inspected by JK, RF. (DWR Sacramento Yard - C. Lund)						
05/28/2013 Debris on waterside flap gate has been removed. (DWR Sacramento Yard - C. Lund)						
09/19/2012 Debris on waterside flap gate. Needs debris removal from the pipe. (DWR UCIP - P. Amatya)						
FIELD_STRUCT_DESC: 24-inch corrugated metal drainage pipe through the levee, 11 feet below the crown. Flap gate is located on the waterside (WS) end. Concrete pad is located on the WS. (24-inch pipe [HLM 3.57] authorized under Automatic Board Order (ABO) issued as Permit No. 10316, 1974 - Stafford). [Additional Reference(s): DWR Levee Log, 1990. USACE Sacramento O&M Manual Unit 120, Willow Slough Channel Relocation and Levee Construction, February 1947, Drawing No. 50-4-2281 Sheet 1 (Station 85+00)]

Waterside view- overview

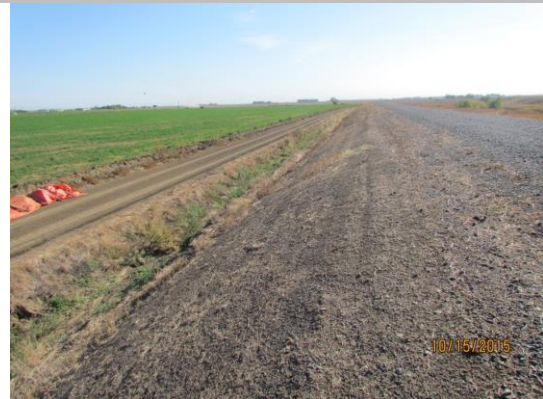
Photo 1 of 1 : FA_2019_ST0012_295_4_20190829_00001.jpg

LM Start	4.12	Rating **	M	Issue No.	4
LM End	4.60	Issue Type +	En	Location *	LS
Category	Earthen Levee			GPS Latitude/Longitude	
				Start	End
Item	Encroachments			38.596784 °	38.599845 °
				-121.737662 °	-121.744830 °
DWR ID	DWR_ST0012_01_s_2012_4				
Comment Code					
DT : Ditch					
Inspector Comment					
A ditch is at the levee toe.

View of the ditch on the landward side of the levee looking downstream.
Fall 2015.

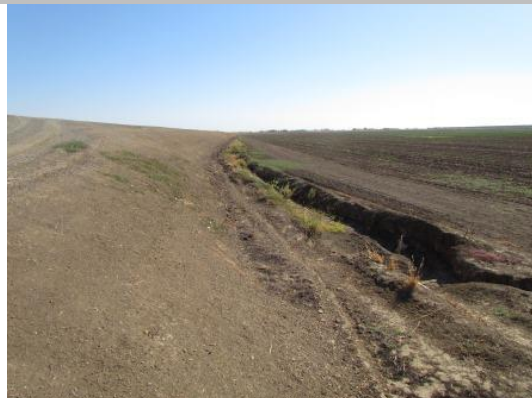
Photo 1 of 2 : FA_2019_ST0012_296_7_20190829_00002.jpg

LM Start	0.29	Rating **	M	Issue No.	7
LM End	0.40	Issue Type +	En	Location *	LS
Category	Earthen Levee			GPS Latitude/Longitude	
				Start	End
Item	Encroachments			38.598993 °	38.599045 °
				-121.749130 °	-121.747107 °
DWR ID	DWR_ST0012_02_f_2019_7				
Comment Code					
DT : Ditch					
Inspector Comment					
The ditch is located at the levee toe.

A view of the ditch near LM 0.29. Fall 2016.

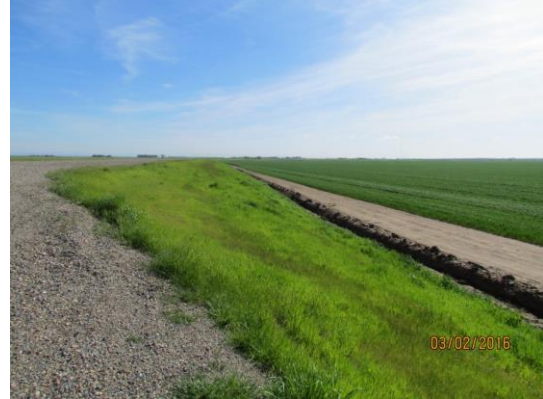
Photo 2 of 2 : FA_2019_ST0012_296_7_20190829_00003.jpg

LM Start	0.29	Rating **	M	Issue No.	7 (cont)	
LM End	0.40	Issue Type +	En	Location *	LS	
Category	Earthen Levee			GPS Latitude/Longitude		
				Start		End
Item	Encroachments			38.598993 °		38.599045 °
				-121.749130 °		-121.747107 °
DWR ID	DWR_ST0012_02_f_2019_7					
Comment Code						
DT : Ditch						
Inspector Comment						
The ditch is located at the levee toe.

View of the ditch on the landward side of the levee looking downstream. Spring 2016.

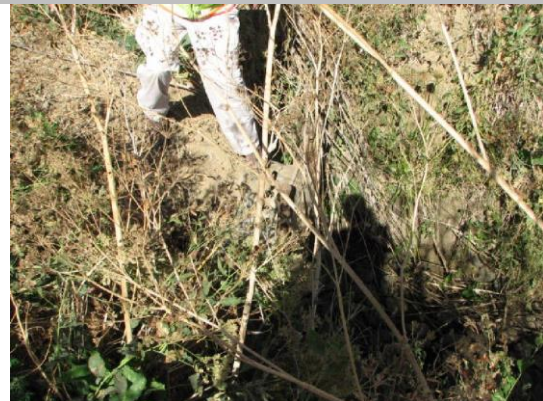
Photo 1 of 3 : UCIP_FA_2019_45286_22464.jpg

Comment Code						
Inspector Comment						
DS_ID:534 FS_ID:45286 EP_NO: 10327 Repair Type: No Action Needed Crossing Status: Found UCIP Comments: 04/12/2017 WS & LS - good/clear, inspected by JK, RF. (DWR Sacramento Yard - C. Lund) 05/24/2013 Flap gate repaired. (DWR Sacramento Yard - C. Lund) 09/20/2012 Flap gate is not properly closing. (DWR UCIP - P. Amatya) FIELD_STRUCT_DESC: 24-inch corrugated drainage pipe through the levee, 17.5 feet below the crown. Flap gate is located on the waterside (WS) slope. (24-inch pipe [HLM 0.78] authorized under Automatic Board Order (ABO) issued as Permit No. 10327 - Heidrick). [Additional Reference(s): DWR Levee Log, 1990. USACE Sacramento O&M Manual Unit 120, Willow Slough Channel Relocation and Levee Construction, February 1947, Drawing No. 50-4-2281 Sheet 1 (Station 47+00)] FS Date: 5/14/2015 1:36:52 PM

Waterside view- concrete headwall and CM pipe

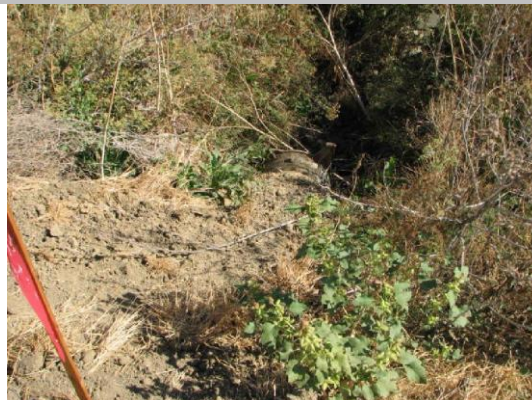
Photo 2 of 3 : UCIP_FA_2019_45286_22460.jpg

Waterside view- overview

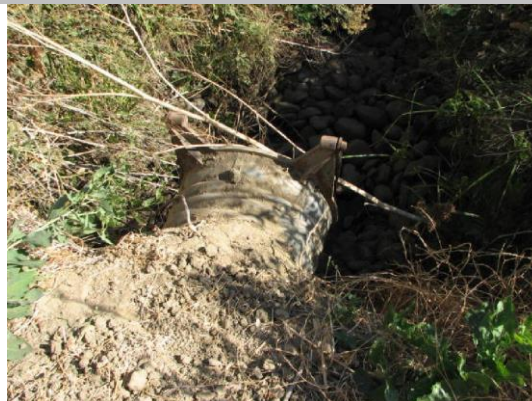
Photo 3 of 3 : UCIP_FA_2019_45286_22461.jpg

Waterside view- CM pipe and flap gate.

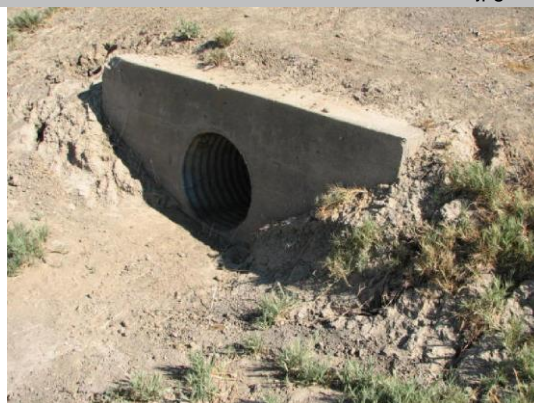
Photo 2 of 3 : UCIP_FA_2019_13725_22469.jpg

Comment Code						
Inspector Comment						
DS_ID:536 FS_ID:13725 EP_NO: 10331 Repair Type: No Action Needed Crossing Status: Found UCIP Comments: 04/12/2017 WS & LS - good/clear, inspected by JK, RF. (DWR Sacramento Yard - C. Lund) 09/20/2012 Landside- upper corner of headwall was chipped off. (DWR UCIP - P. Amatya) FIELD_STRUCT_DESC: 24-inch corrugated metal drainage pipe through the levee, 13.5 feet below the crown. Flap gate is located on the waterside (WS) end. (24-inch pipe [HLM 1.15] authorized under Automatic Board Order (ABO) issued as Permit No. 10331, 1974 - Lavezzo). [Additional Reference(s): DWR Levee Log, 1990. USACE Sacramento O&M Manual Unit 120, Willow Slough Channel Relocation and Levee Construction, February 1947, Drawing No. 50-4-2281 Sheet 1 (Station 66+98)] FS Date: 5/24/2013 8:22:08 AM

Landside view- concrete headwall and pipe

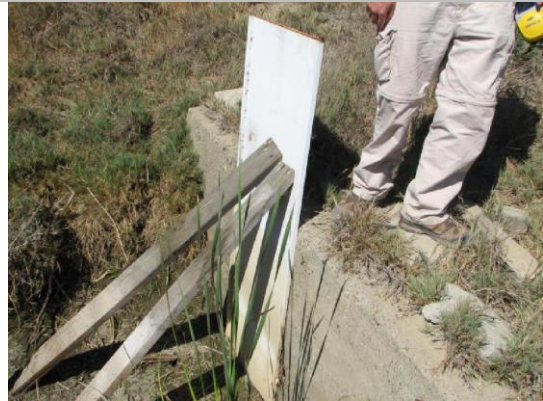
Photo 1 of 3 : UCIP_FA_2019_45291_22479.jpg

Landside view- concrete headwall and pipe (temporarily closed used wooden planks).

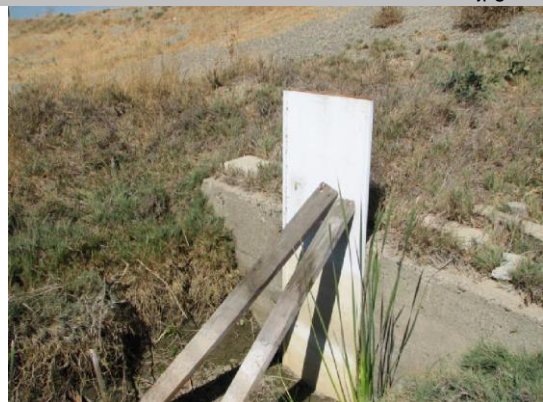
Photo 2 of 3 : UCIP_FA_2019_45291_22478.jpg

Landside view- concrete headwall

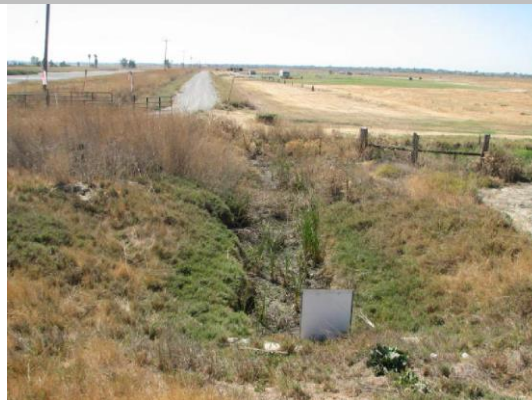
Photo 3 of 3 : UCIP_FA_2019_45291_22477.jpg

Comment Code					
Inspector Comment					
DS_ID:538 FS_ID:45291 EP_NO: 10328 Repair Type: No Action Needed Crossing Status: Found UCIP Comments: 04/12/2017 WS & LS - good/clear, inspected by JK, RF. (DWR Sacramento Yard - C. Lund) FIELD_STRUCT_DESC: 24-inch corrugated metal drainage pipe through the levee, 11 feet below the crown. Flap gate is located on the waterside (WS) end. (24-inch pipe [HLM 2.90] authorized under Automatic Board Order (ABO) issued as Permit No. 10328, 1974 - Heidrick). [Additional Reference(s): DWR Levee Log, 1990. USACE Sacramento O&M Manual Unit 120, Willow Slough Channel Relocation and Levee Construction, February 1947, Drawing No. 50-4-2281 Sheet 2 (Station 158+69)] FS Date: 5/14/2015 1:40:56 PM

Landside view- open ditch.

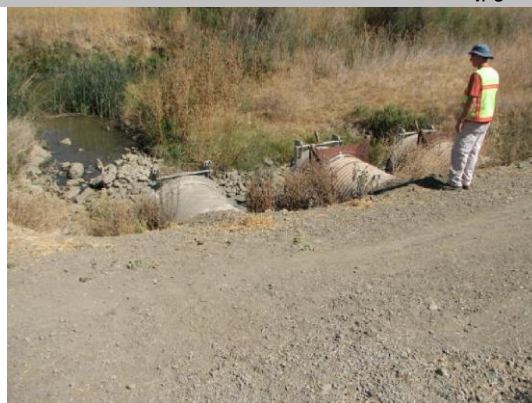
Photo 1 of 3 : UCIP_FA_2019_45294_22789.jpg

Comment Code					
Inspector Comment					
DS_ID:541 FS_ID:45294 EP_NO: 10335 Repair Type: No Action Needed Crossing Status: Found UCIP Comments: 09/20/2012 Landside view photos are missing. Daylight pipe is a steel pipe. The pipe through the levee may be a CMP. (DWR UCIP - P. Amatya) FIELD_STRUCT_DESC: 1 of 2. 42-inch corrugated metal drainage pipe through the levee, 12 feet below the crown. Flap gate located on the waterside (WS) end. 42-inch pipe sleeved through a 48-inch corrugated metal pipe (CMP). (two 48-inch pipes [HLM 3.54] authorized under Automatic Board Order (ABO) issued as Permit No. 10335, 1974 - Snyder). [Additional Reference(s): DWR Levee Log, 1990. USACE Sacramento O&M Manual Unit 120, Willow Slough Channel Relocation and Levee Construction, February 1947, (Station 192+80)] FS Date: 5/14/2015 1:41:55 PM

Waterside overview- middle 42-inch pipe.

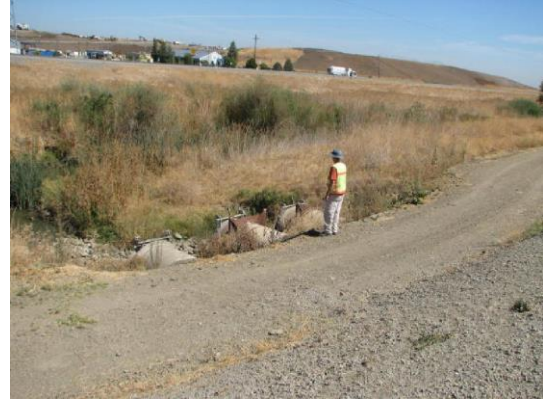
Photo 2 of 3 : UCIP_FA_2019_45294_22788.jpg

Waterside overview-

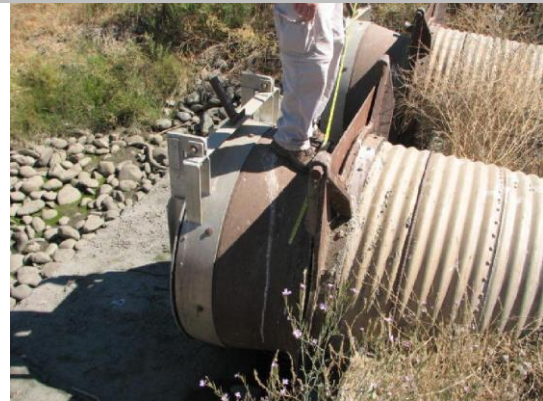
Photo 3 of 3 : UCIP_FA_2019_45294_22792.jpg

Waterside view- 42-inch steel pipe and flap gate.

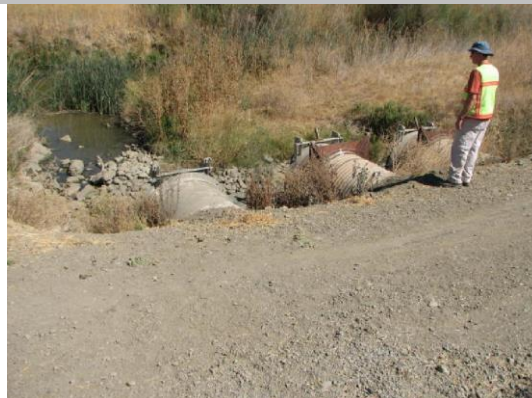
Photo 1 of 3 : UCIP_FA_2019_45295_22794.jpg

Waterside overview- far right 42-inch pipe.

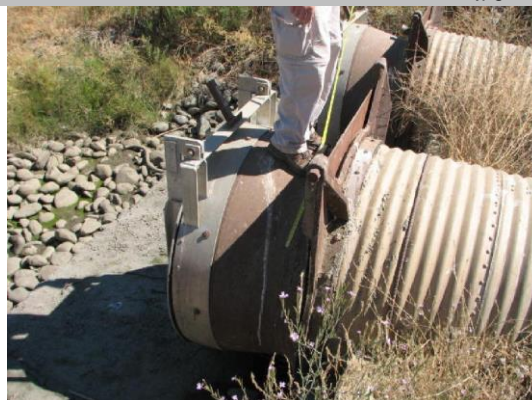
Photo 2 of 3 : UCIP_FA_2019_45295_22793.jpg

Waterside view- 42-inch steel pipe and flap gate (right).

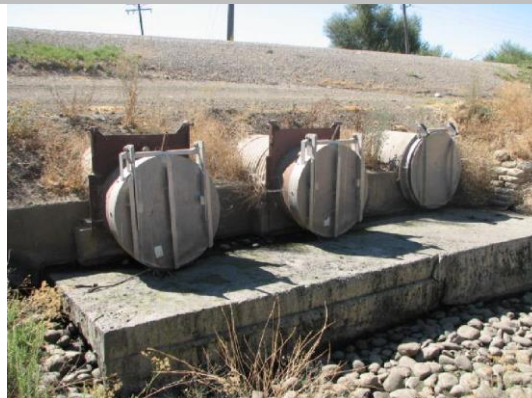
Photo 3 of 3 : UCIP_FA_2019_45295_22796.jpg

Waterside overview- outlet structure.

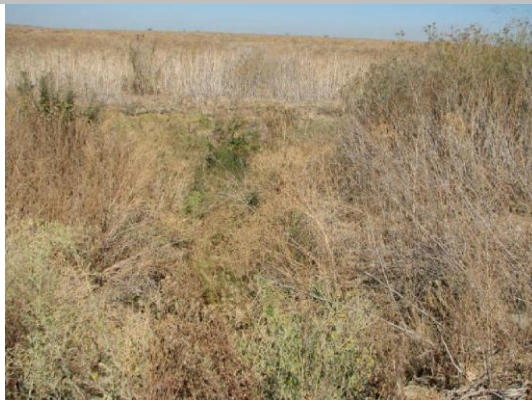
Photo 2 of 3 : UCIP_FA_2019_45298_22804.jpg

Landside overview

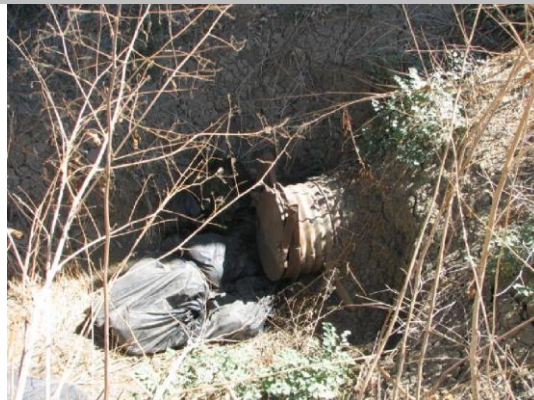
Photo 1 of 3 : UCIP_FA_2019_45285_22809.jpg

Comment Code					
Inspector Comment					
DS_ID:546 FS_ID:45285 EP_NO: 10319 Repair Type: Non-Urgent Crossing Status: Found UCIP Comments: 04/12/2017 WS & LS - good/clear, inspected by JK, RF. (DWR Sacramento Yard - C. Lund) 05/24/2013 Material removed from inlet last fall. Outlet cleared. (DWR Sacramento Yard - C. Lund) 09/20/2012 Soil and debris on inlet mouth. (DWR UCIP - P. Amatya) FIELD_STRUCT_DESC: 24-inch corrugated metal drainage pipe through the levee, 15 feet below the crown. Flap gate is located on the waterside (WS) end. (18-inch pipe [HLM 4.52] authorized under Automatic Board Order (ABO) issued as Permit No. 10319, 1974 - Bell) [Additional Reference(s): DWR Levee Log, 1990. USACE Sacramento O&M Manual Unit 120, Willow Slough Channel Relocation and Levee Construction, February 1947, Drawing No. 50-4-2281 Sheet 4 (Station 244+47)] FS Date: 5/14/2015 1:36:11 PM

Waterside view- pipe and flap gate.

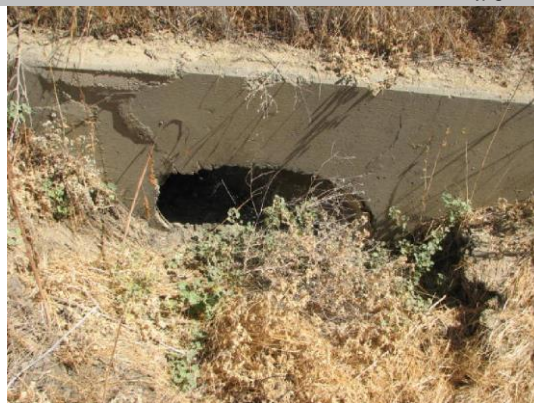
Photo 2 of 3 : UCIP_FA_2019_45285_22811.jpg

Landside view- pipe and headwall.

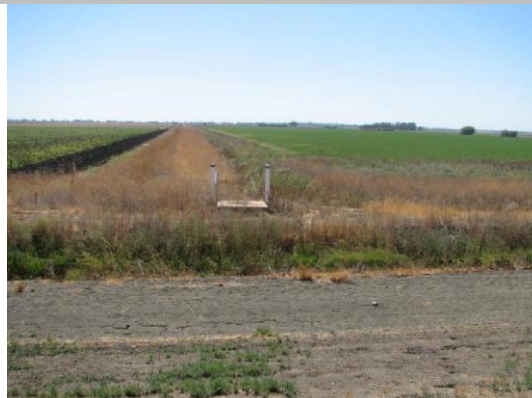
Photo 1 of 3 : UCIP_FA_2019_45301_22845.jpg

Landside view- overview

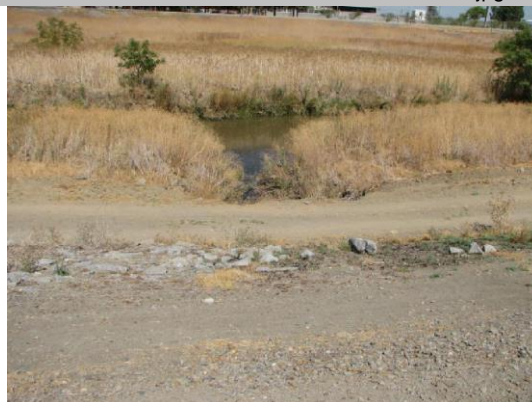
Photo 2 of 3 : UCIP_FA_2019_45301_22844.jpg

Waterside view- overview

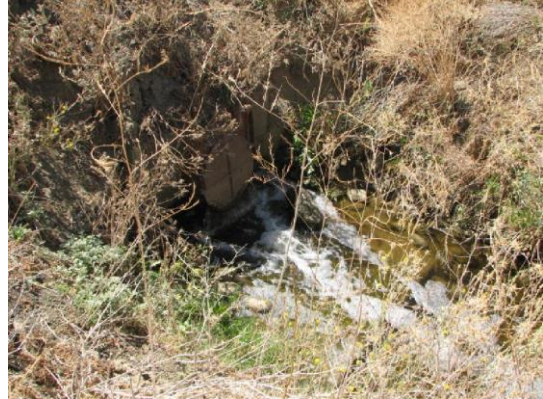
Photo 3 of 3 : UCIP_FA_2019_45301_22846.jpg

Waterside view- pipe and flap gate. Water was running in the pipe during the survey.

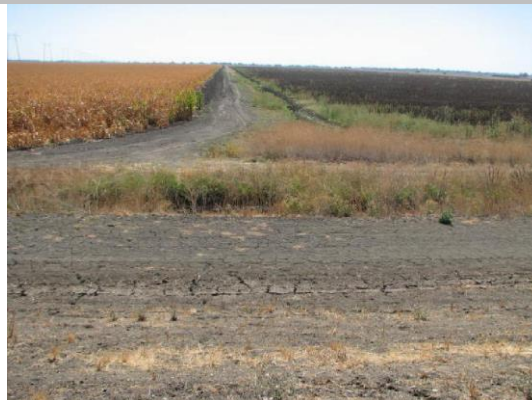
Photo 1 of 3 : UCIP_FA_2019_45302_22849.jpg

Landside view-overview

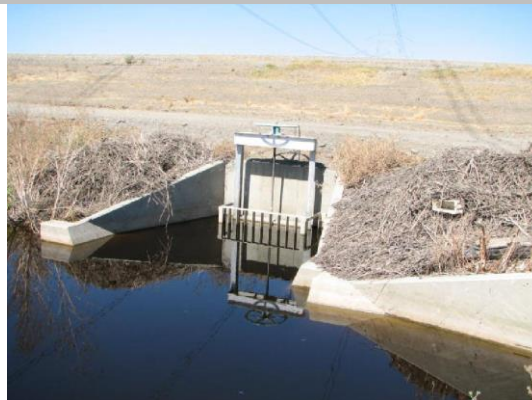
Photo 1 of 3 : UCIP_FA_2019_54251_22858.jpg

Comment Code						
Inspector Comment						
DS_ID:17696 FS_ID:54251 EP_NO: 16700 Repair Type: Non-Urgent Crossing Status: Found UCIP Comments: 07/23/2019 CVFPB approved Compliance Plan and Schedule of pipe rehabilitation due to a sinkhole discovered at WS berm of levee near pipe alignment. (O.Yakimov - DWR UCIP)09/20/2012 No pump station found in landside of the levee. A slide gate was found on landside of the levee. (DWR UCIP - P. Amatya) FIELD_STRUCT_DESC: 48-inch reinforced concrete drainage pipe through the levee, 19 feet below the crown. Pipe goes through both levees and under the Willow Slough Bypass. Inlet structure, slide gate and trash rack, is located on the landside (LS). (48-inch pipe authorized under Permit No. 16700, 1998 - City of Davis) FS Date: 7/23/2019 10:14:01 AM

Landside view- inlet structure.

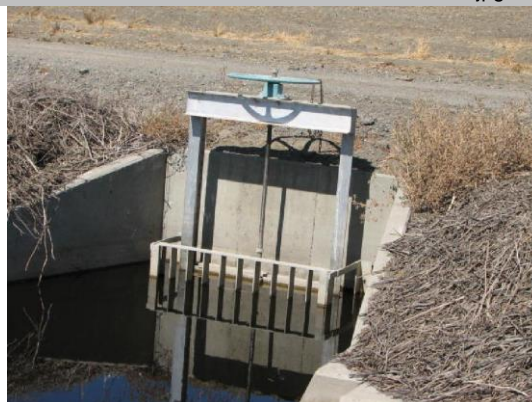
Photo 2 of 3 : UCIP_FA_2019_54251_22857.jpg

Landside view- trash rack and slide gate in inlet structure.

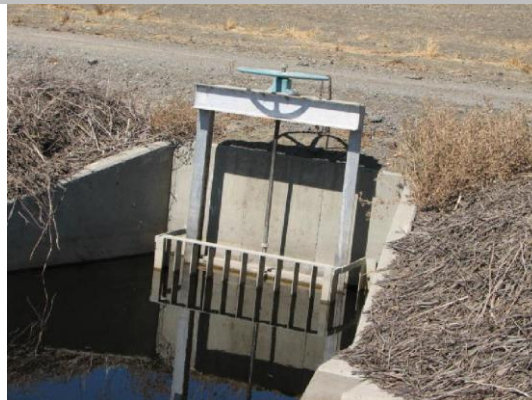
Photo 3 of 3 : UCIP_FA_2019_54251_22856.jpg

Landside view- Headwall with wing walls.

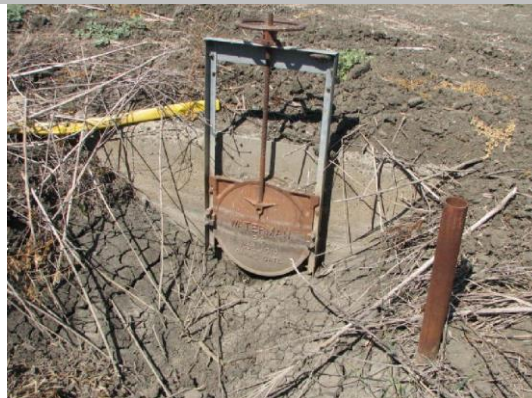
Photo 1 of 3 : UCIP_FA_2019_45305_22861.jpg

Landside view- inlet structure.

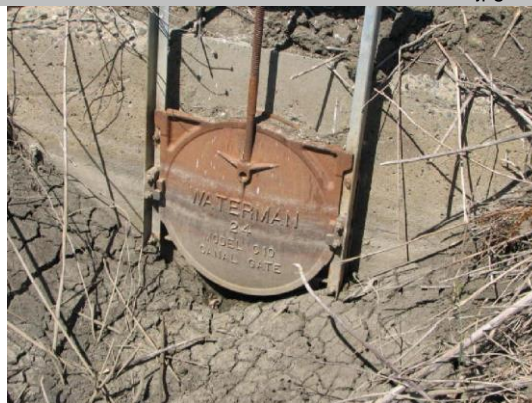
Photo 2 of 3 : UCIP_FA_2019_45305_22860.jpg

Landside view- concrete headwall and slide gate.

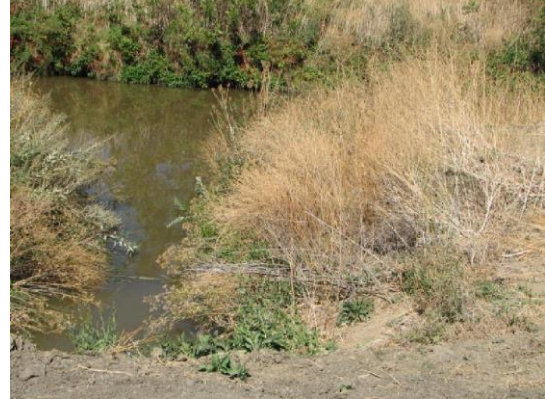
Photo 3 of 3 : UCIP_FA_2019_45305_22859.jpg

Waterside view- overview.

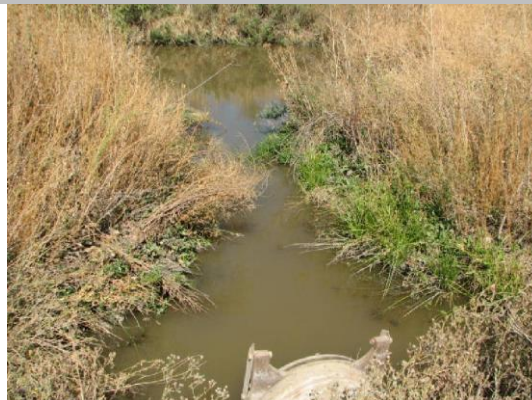
Photo 1 of 3 : UCIP_FA_2019_45306_22873.jpg

Waterside view- overview.

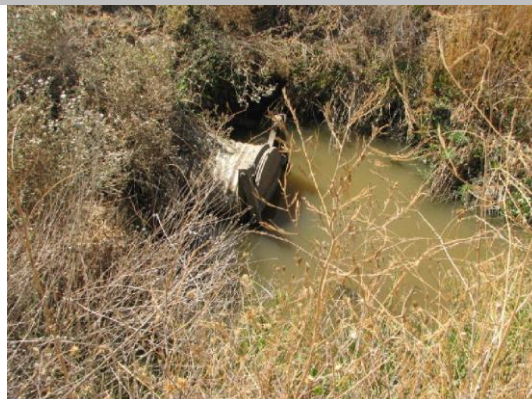
Photo 2 of 3 : UCIP_FA_2019_45306_22872.jpg

Waterside view- pipe and flap gate.

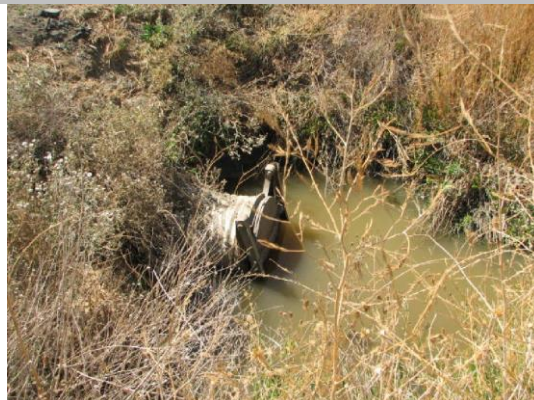
Photo 3 of 3 : UCIP_FA_2019_45306_22876.jpg

Waterside view- pipe and flap gate.

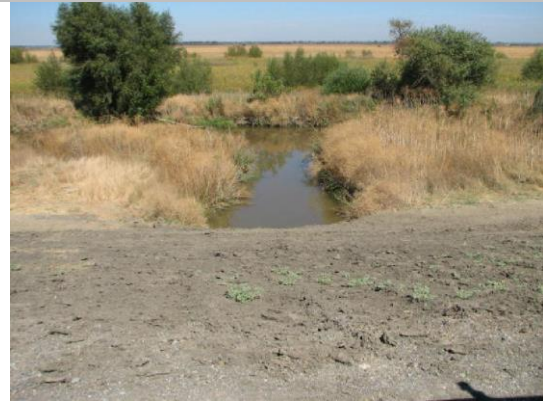
Photo 1 of 3 : UCIP_FA_2019_45307_22869.jpg

Waterside view- overview

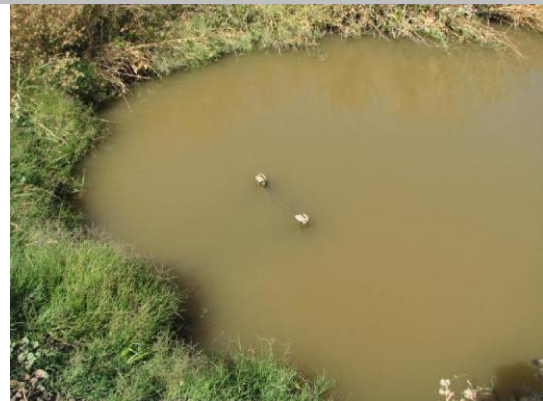
Photo 2 of 3 : UCIP_FA_2019_45307_22868.jpg

Waterside view- outlet structure under the water.

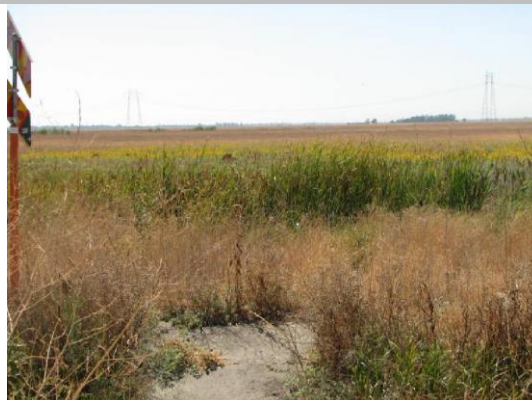
Photo 3 of 3 : UCIP_FA_2019_45307_22870.jpg

Landside view- overview

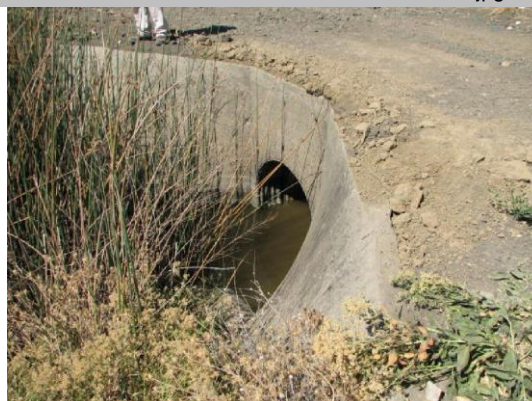
Photo 1 of 2 : UCIP_FA_2019_45309_22878.jpg

Comment Code						
Inspector Comment						
DS_ID:555 FS_ID:45309 EP_NO: 10338 Repair Type: No Action Needed Crossing Status: Found UCIP Comments: 04/12/2017 WS & LS - submerged in water, inspected by JK, RF. (DWR Sacramento Yard - C. Lund) FIELD_STRUCT_DESC: 42-inch corrugated metal drainage pipe through the levee, 23.5 feet below the crown. Flap gate is located on the waterside (WS) end. Concrete headwall with wing walls is located on the landside (LS). (42-inch pipe [HLM 6.92] authorized under Automatic Board Order (ABO) issued as Permit No. 10338, 1974 - Woodland Farms, Ltd) [Additional Reference(s): DWR Levee Log, 1990. USACE Sacramento O&M Manual Unit 120, Willow Slough Channel Relocation and Levee Construction, February 1947, Drawing No. 50-4-2281 Sheet 5 (Station 374+00)] FS Date: 5/14/2015 1:46:34 PM

Landside view- Wing wall and pipe

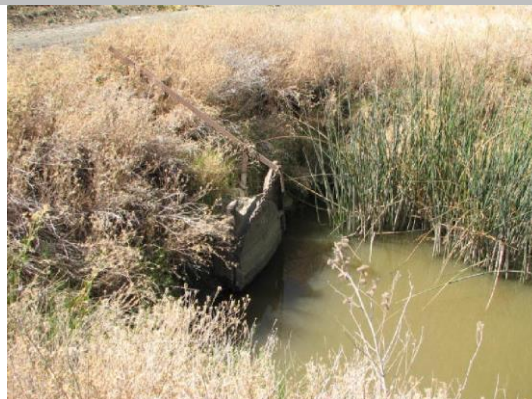
Photo 2 of 2 : UCIP_FA_2019_45309_22877.jpg

LM Start	7.01	Rating **	A/W	Issue No.	50 (cont)
LM End	7.01	Issue Type +	Ma	Location *

Waterside view- pipe and flap gate
